Greenfield Estates
Olympia, WA 98501

Street Tree Removal and Replacement Plan

Prepared for: Greenfield Estates HOA

Prepared by: Kevin M. McFarland, SUF
Consulting Urban Forester/ISA Certified Arborist & Tree Risk Assessor Qualified

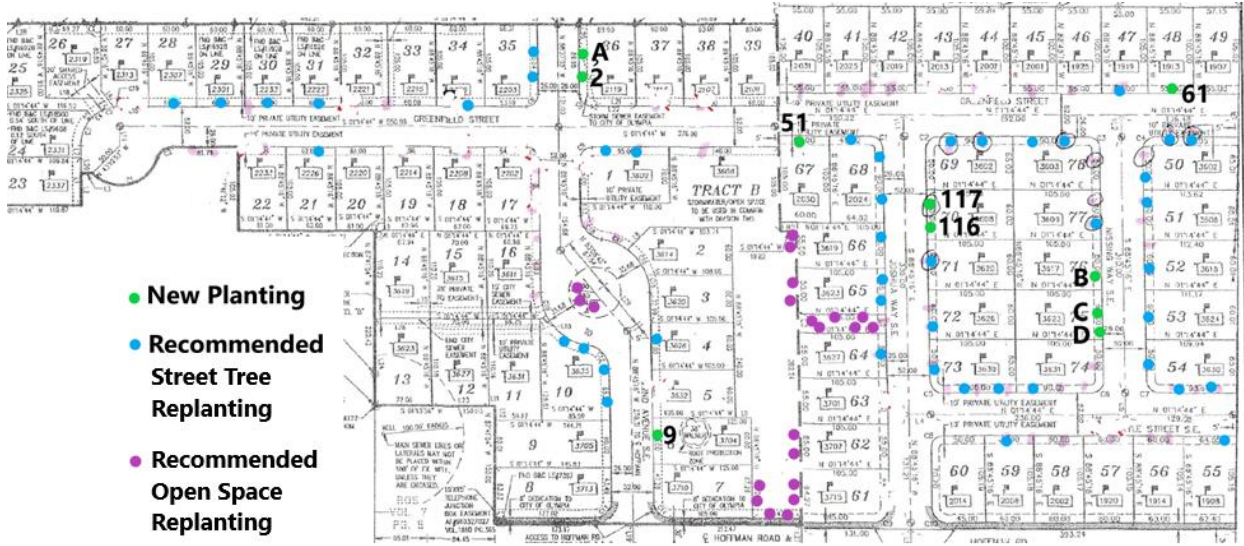
Locations of New Plantings and Recommend Replacements

It appears that a total of eleven trees have been replanted since my 2018 assessment. Four of these are in locations where no tree previously existed. Replanted trees are noted in Table 1 and in green on the attached Replanting map.

Per my discussions with Olympia's Urban Forestry Program Manager Jasen Johns and my findings, it will be mandatory that the HOA replant at a 1:1 ratio for all trees that have been removed since my 2018 assessment. This must be completed prior to any additional removals in order to satisfy canopy cover requirements. Due to the constraints of the site, I am also recommending that not all trees be replaced at the same locations. Many of the trees were placed inappropriately and interfere with sight distances or are simply in areas that are unsuitable for trees of any size. Mr. Johns has directed me to identify other locations within the development where trees can be planted to make up any shortfalls. Replanting locations are noted in blue and purple on the attached map.

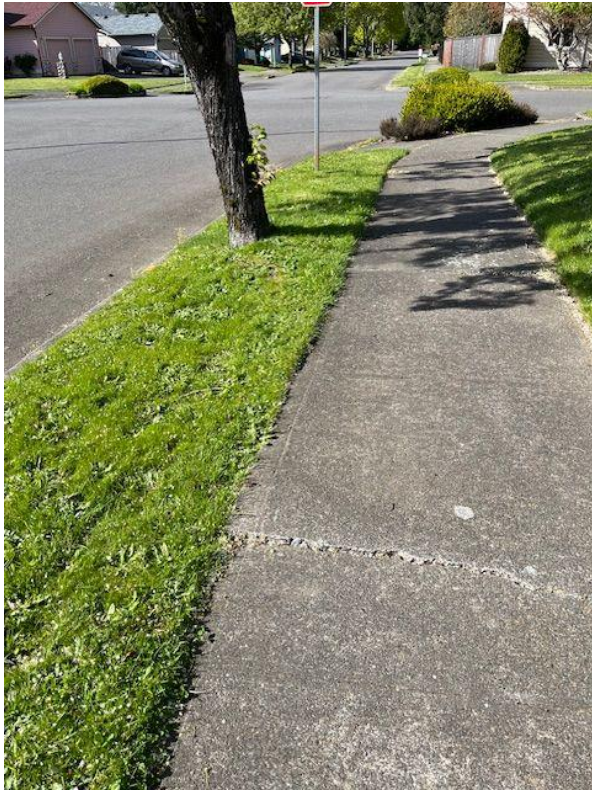
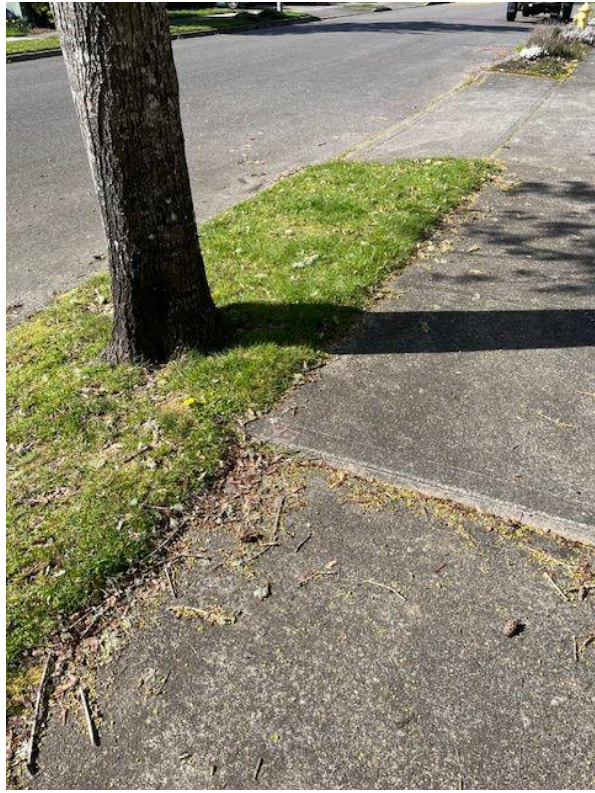
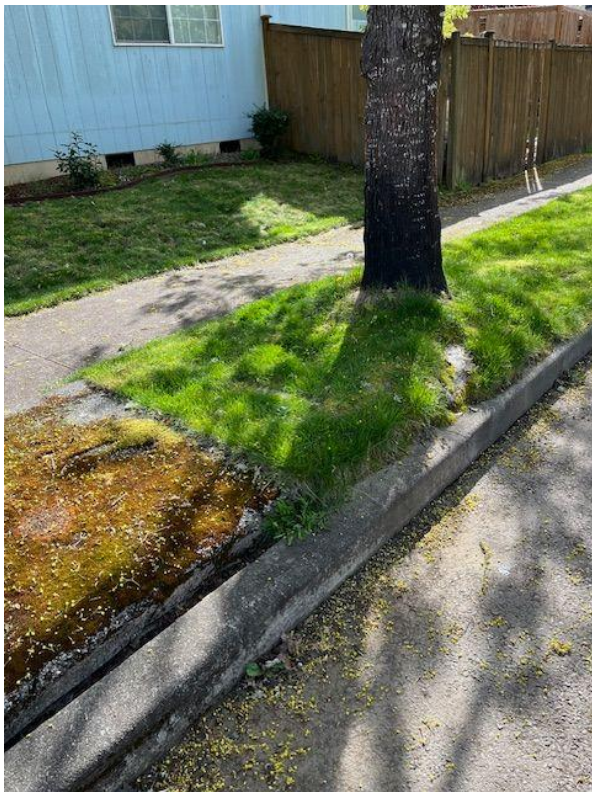
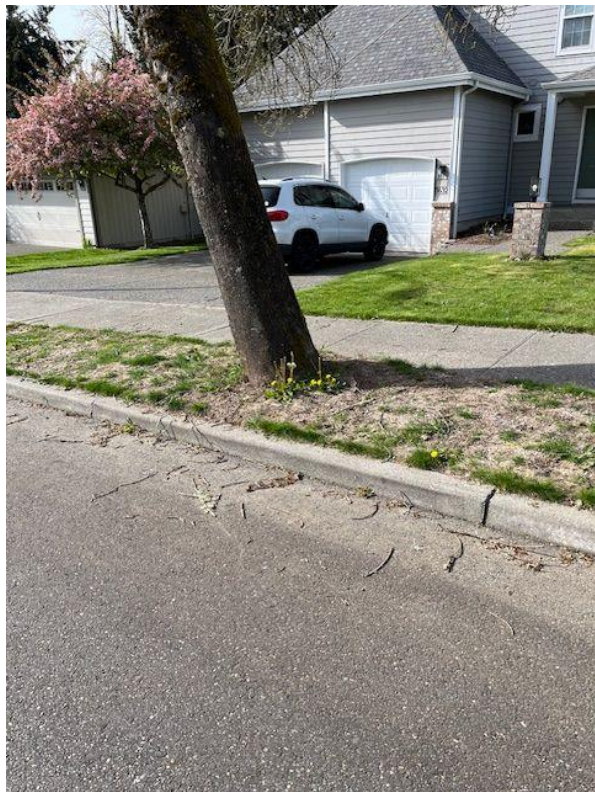
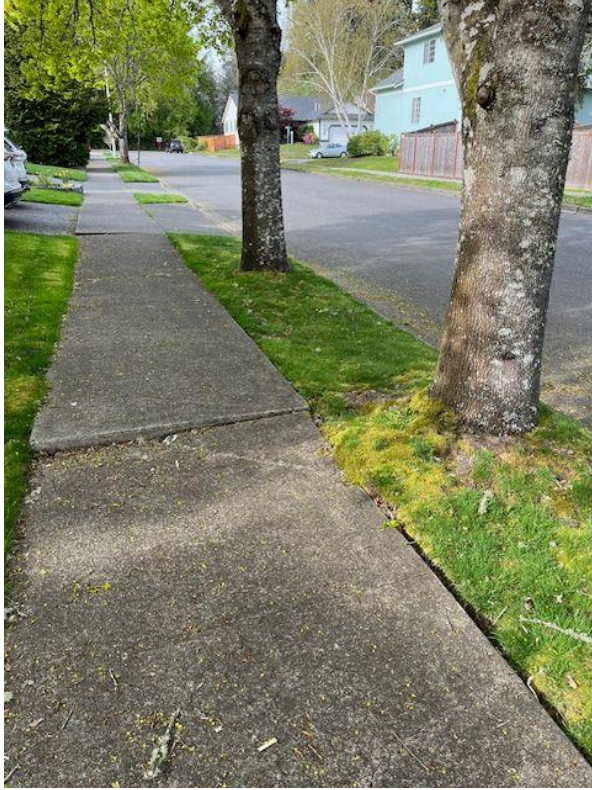
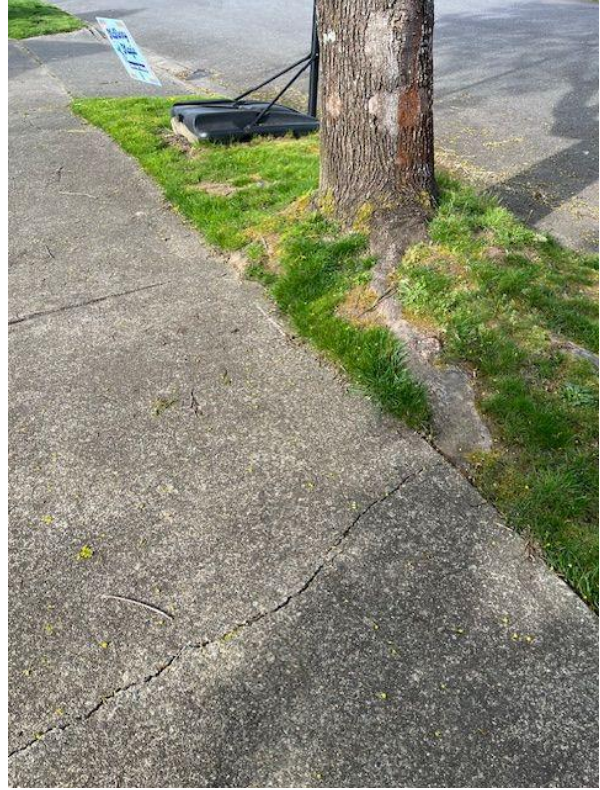
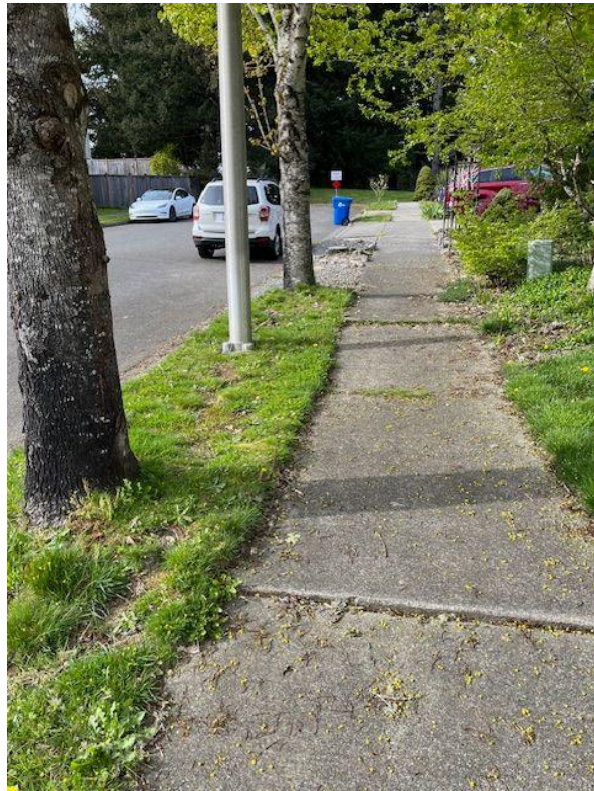
Photos

A total of 118 trees were listed in my 2018 report. The table below has been updated to reflect what is currently found at the site. Locations are shown on the attached original plat maps and photos of the associated sidewalk and curb damage have been included.
